AAMA 501-05 Performance Test Report

Series: 7000 - 2 1/2" x 7" Curtain Wall

Product/Type: Pressure Plate Stick Curtain Wall

REPORT #CCLI-15-018

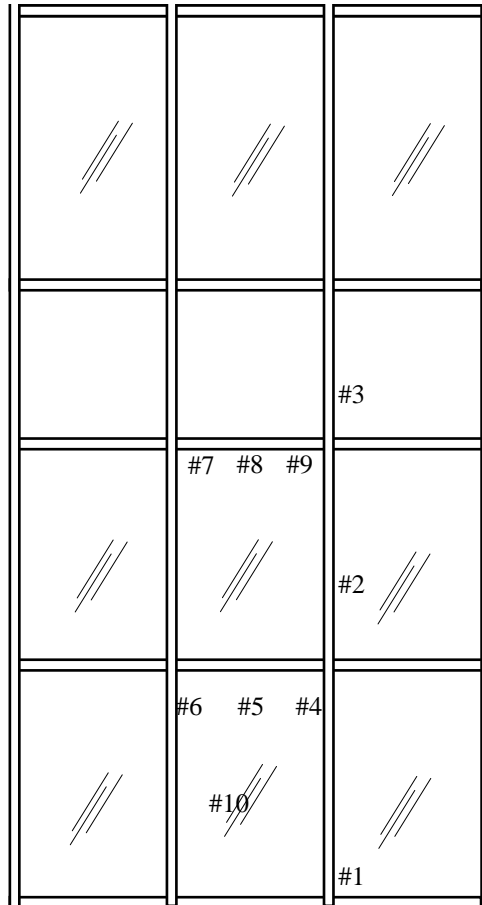
Dial Indicator Location Diagram

Dial indicators were installed to measure deflection and residuals at ends and midspan of typical horizontal and vertical members, **Dial Indicator Location Diagram, Appendix B.**

Results: Passed with all Positive and Negative net deflections below the allowable.

Results: Passed with all Positive and Negative Permanent sets below the allowable.

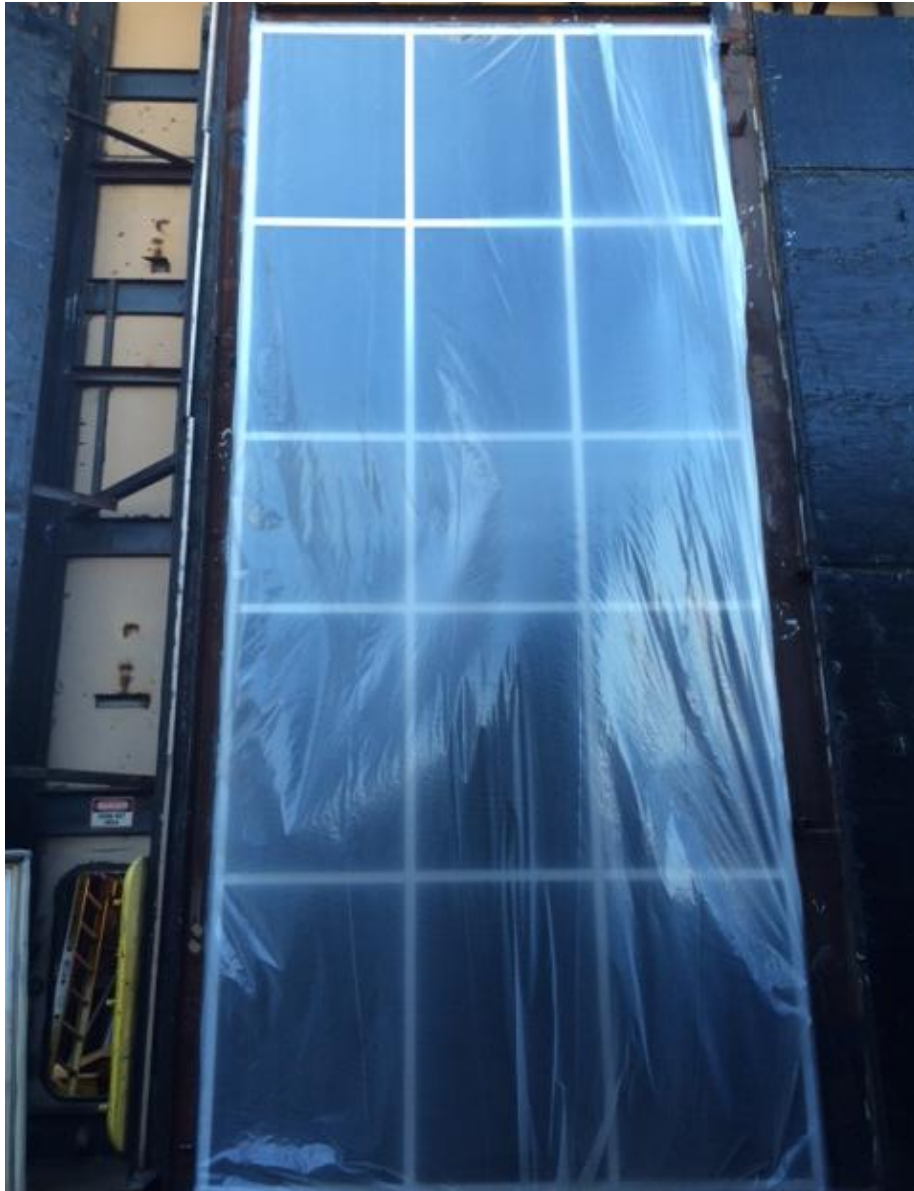
PHOTOGRAPH 1

The specimen and perimeter sealant joints were completely covered with an impervious 4 mm plastic material and duct tape, thus allowing no movement of air through the specimen. The exterior face of the specimen was subjected to a positive pressure differential of 6.24 psf to obtain a leakage rate for the test chamber. The plastic bag was removed and the total chamber and specimen infiltration was measured. The chamber infiltration was subtracted from the total air infiltration resulting in the infiltration rate of the test specimen, **Photograph 1, Appendix C**.

Results: 9.37Cfm/ 337.05 = 0.027 Cfm/ft² / **Report:** 0.03 Cfm/ft²

Static Pressure Air Infiltration Test @ 6.24 psf per ASTM E 283-04

Results: $9.37\text{Cfm} / 337.05 = 0.027 \text{ Cfm/ft}^2$ / **Report:** 0.03 Cfm/ft^2

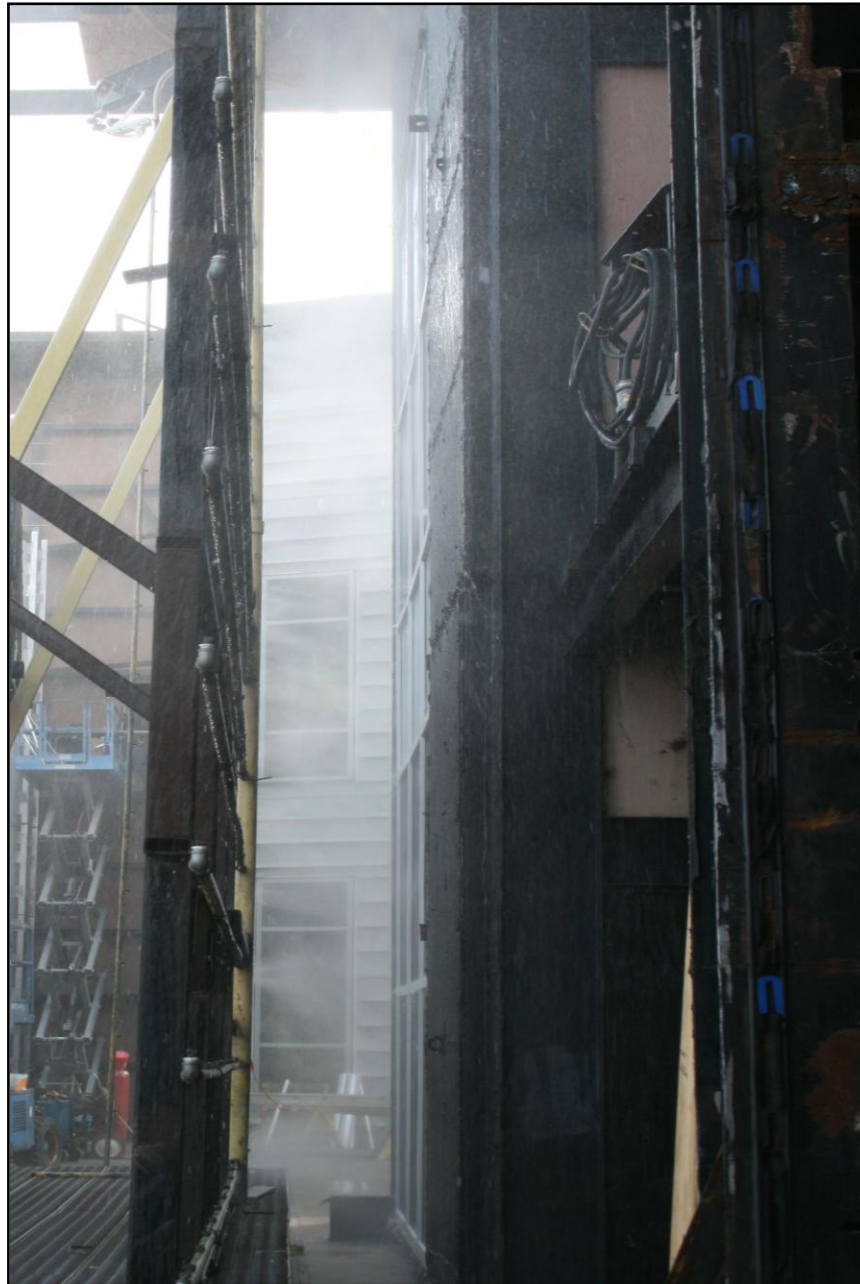
PHOTOGRAPH 2

Water was applied to the exterior face of the specimen at a minimum rate of five (5) gallons per square foot per hour of wall area, in such a way as to continuously and completely cover the exterior face of the specimen. Simultaneously, a positive **inward** differential static pressure of **12 psf** was applied against the face. The application of pressure and water was maintained for a period of fifteen (15) minutes, with observers inside the chamber checking for water penetration, **Photograph 2, Appendix C.**

12.0 Psf Results: Passed with no water penetration observed.

Static Pressure Water Penetration Test @ 12 psf per ASTM E 331-00

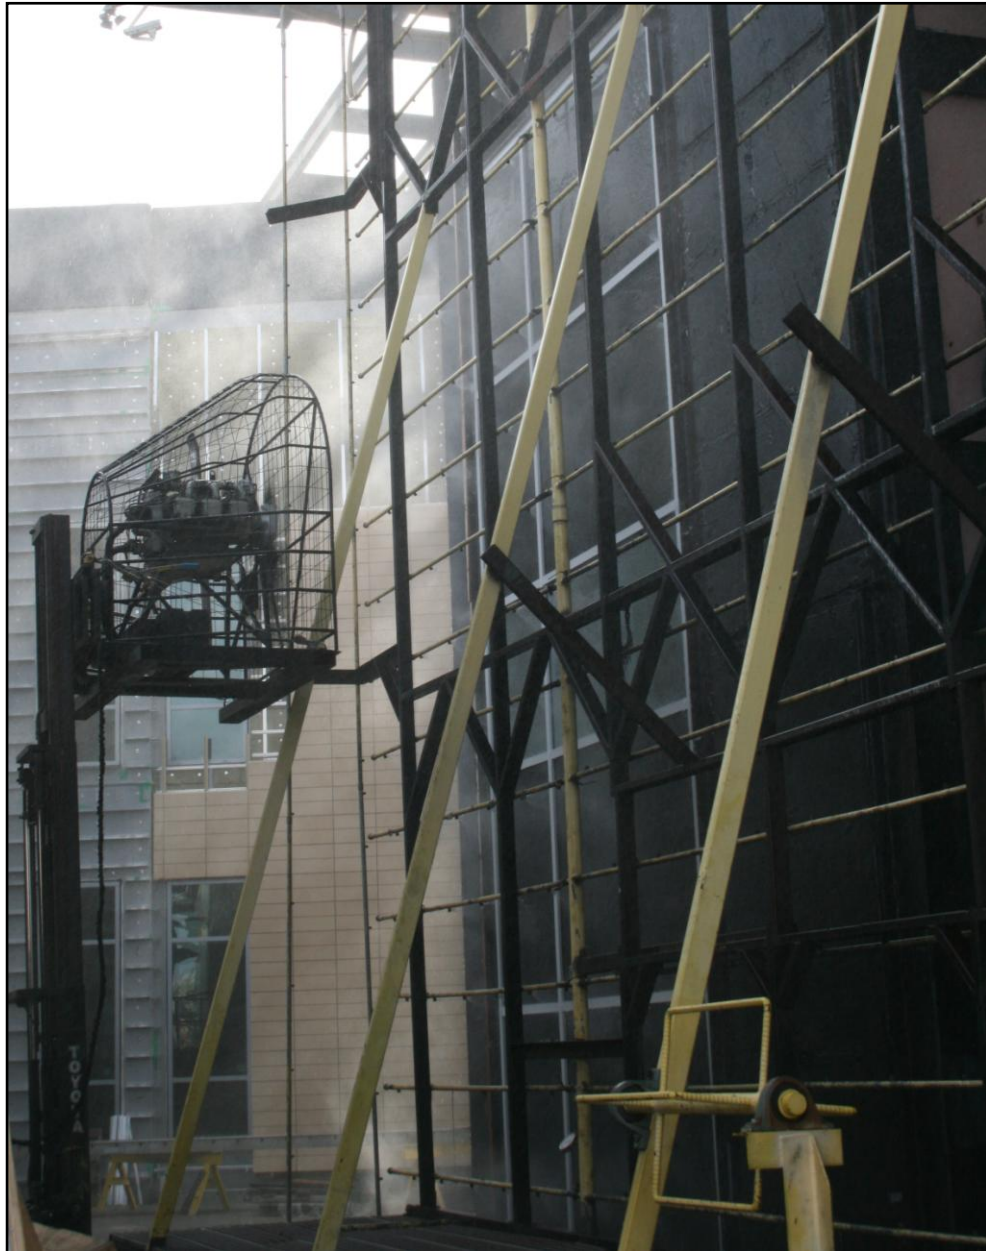
PHOTOGRAPH 3

Water was applied to the exterior face of the specimen at a minimum rate of five (5) gallons per square foot per hour of wall area, in such a way as to completely and continuously cover the face of the specimen. Simultaneously, the wall was subjected to sufficient airflow from an aircraft engine with a two (2) blade propeller, approximately 6'-0" in diameter, approximately 10' in front of the specimen. The application of airflow and water was maintained for a period of fifteen (15) minutes, with observers inside the chamber checking for water penetration, **Photograph 3, Appendix C.**

Results: Passed with no water penetration observed.

Dynamic Water Penetration @ 68 mph Slipstream Velocity per AAMA 501.1-05
